Manhole Inspection Summary

Manhole # S31KK1007MH

Insp Date: **2/22/07 1:19 PM**

Location Address: **4305 RUGBY RD**

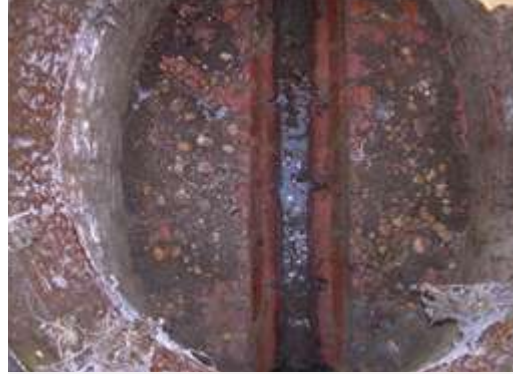
Top View

Bench debris.

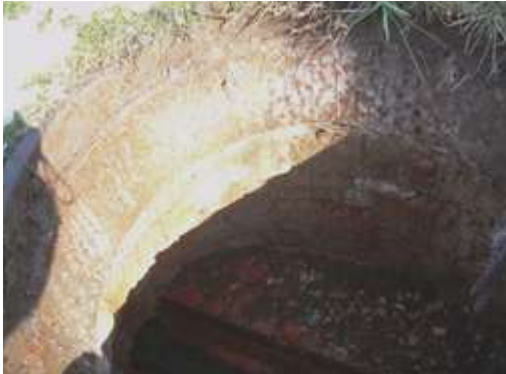
Defect

Condition: ☐ Sound ☐ Cracked ☐ Root Intrusion ☐ Loose Brick ☒ **Deteriorated**

Infiltration: ☐ None ☒ **Joint** ☐ Cracks ☒ **Mortar** ☐ Roots ☐ Wall

Infiltration: ☐ None ☐ Joint ☐ Cracks ☒ **Mortar** ☐ Roots ☒ **Wall**

Adjustment and Corbel deterioration and infiltration. Barrel infiltration.

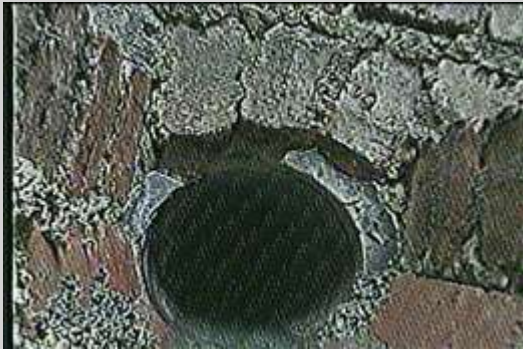
Pipe Out @ 12 O'Clock

Comments **The I6 pipe seal is not flush to the pipe.**

Barrel deterioration and infiltration.

Infiltration: **None** Pipe Seal Cond: **Broken**

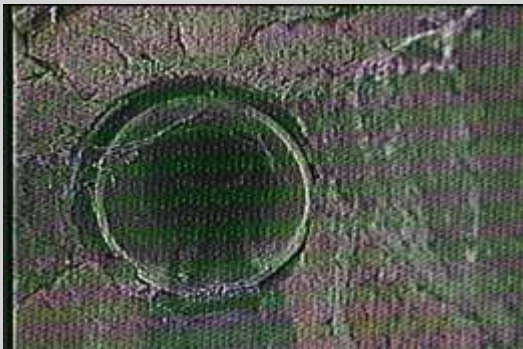
Pipe In @ 6 O'Clock

Condition: ☐ Sound ☐ Cracked ☐ Root Intrusion ☒ **Deteriorated** ☐ Leaks ☐ Debris

Channel deterioration.
